## **Test Observations**

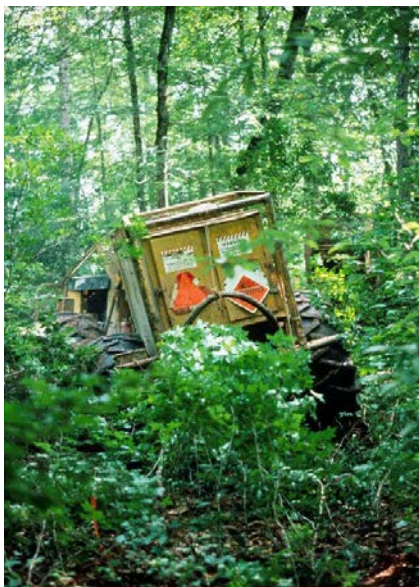
Ardco water buggy and drilling rig (in background) in heavy cover left and right water buggy fitted with Terra Tires

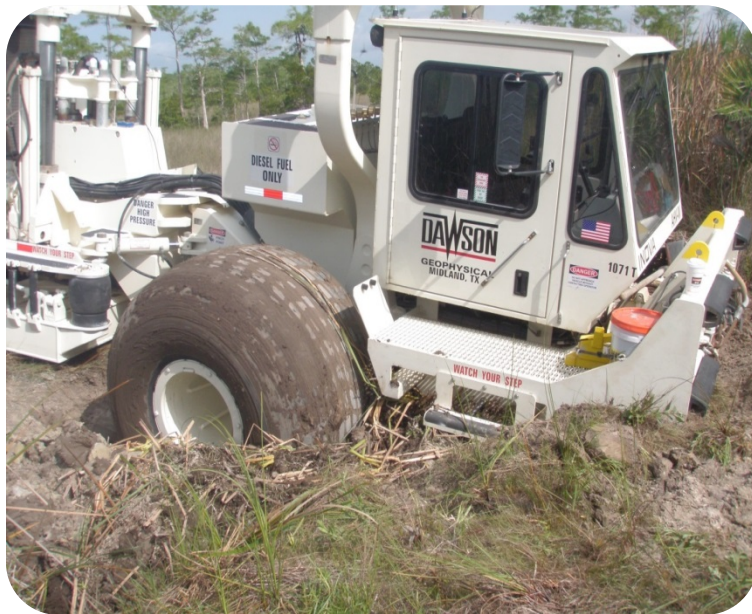
Upon arrival at the site at the scheduled time, Preserve staff were informed that the vibroseis buggy had already begun its test run and had become stuck. The Preserve observers headed for the vehicle in an NPS swamp buggy, following the route the vibroseis buggy took until the observers came upon it stuck in a ditch that it had attempted to cross. While the NPS and applicants observers were there, attempts were made to pull the vehicle out with a 4x4 truck, but

Several hours passed before the vibroseis buggy was freed with the help of a tractor equipped with a back hoe and bucket provided by Whitten Equipment Company. Burnett representatives and their seismic exploration contractor (Dawson Geophysical) explained that under normal circumstances an accompanying vibroseis buggy would have pulled the buggy free. Once freed the buggy was capable of negotiating open and sparsely wooded habitat with little to no difficulty. However, the selected route was primarily along existing trails. Time expended on buggy retrieval reduced overall time available to test the equipment in some of the more challenging habitat that was scouted for testing. During testing Dawson Geophysical buggy operator stopped at various intervals and demonstrated full vibration sweeps.
